RISO INC. TECHNICAL INFORMATION BULLETIN

Subject: Clamp Plate Base/ Starter Roller | Bulletin No: 40

SUBJECT: Notification of part number duplication of the Roller Starter Part #002-12132

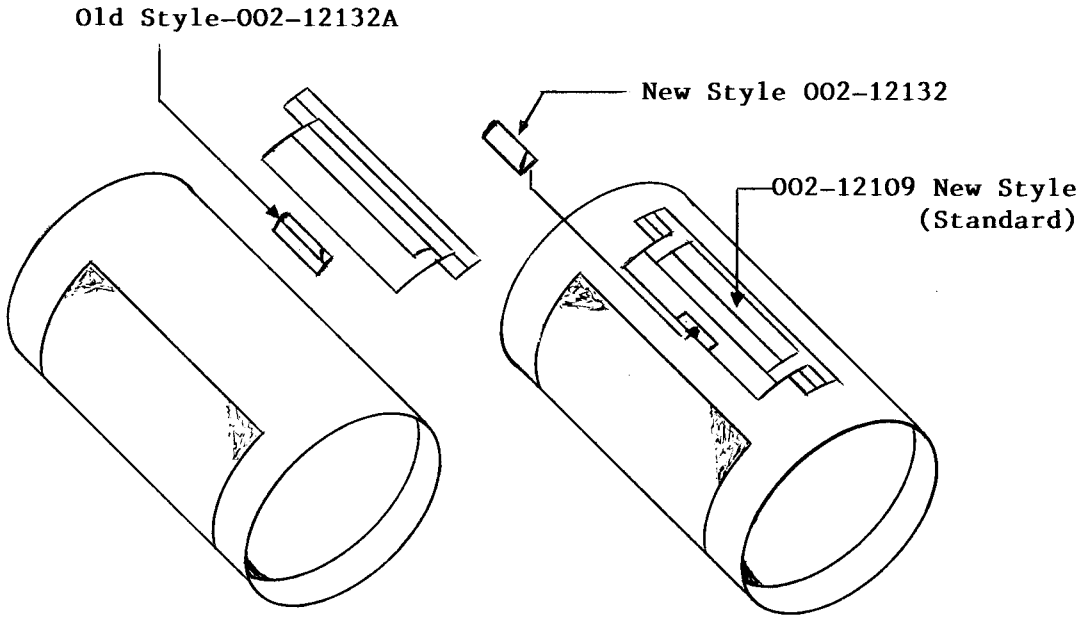
ISSUE: There are two different roller starters and clamp plate bases as shown below.

IMPORTANT NOTES: The clamp plate base plates have separate part numbers. Please refer to your parts book. In the unlikely event of part replacement, Riso, Inc. will supply the standard style clamp plate base #002-12109 only. Therefore it may be necessary to distinquish the old style roller starter from the new style. Check the parts book diagram and please change your parts and price book as follows:

OLD STYLE	NEW STYLE	NOTES
002-12132A	002-12132	Both numbers are stocked by Riso.
